> NORWALK COMMUNITY INFRASTRUCTURE STUDY

RESULTS OF INFRASTRUCTURE INVESTIGATION

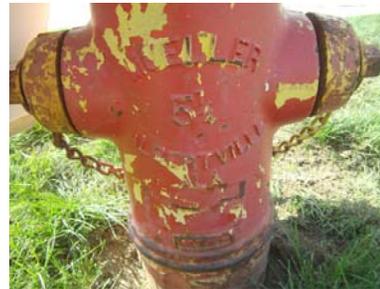
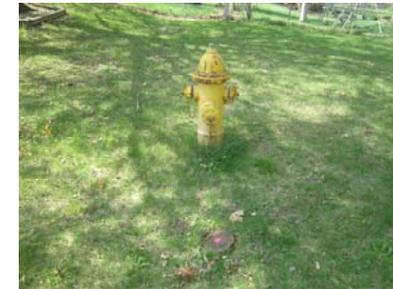
Fire Hydrants

- Old and Worn Paint
- Grade Adjustments Needed
- Valve Box Adjustments Needed

- Most Defects Low Priority

- Most Work Could Be Done By City Crews Over Time

- Total Cost = \$ 8,750

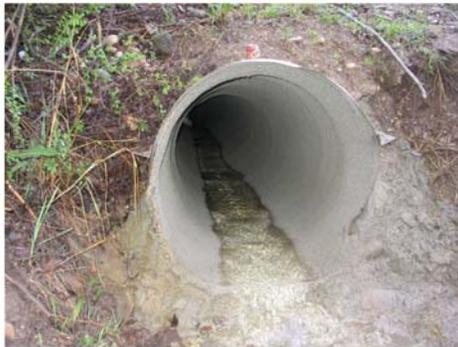
Centrifugally Cast Concrete Pipe

Structurally Rehabilitated Storm Culvert

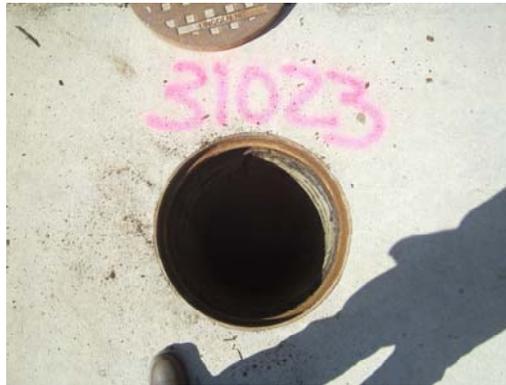
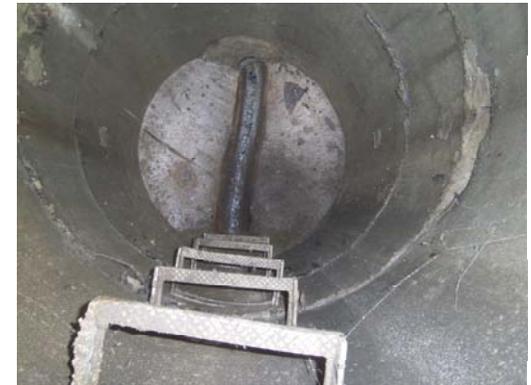
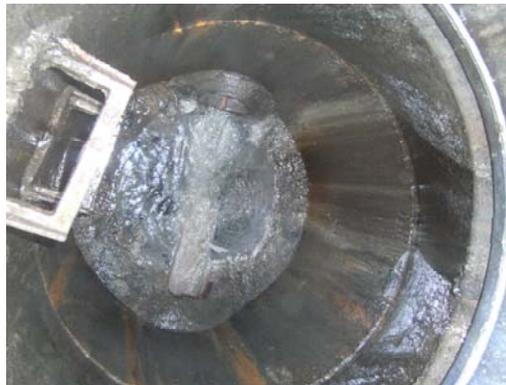
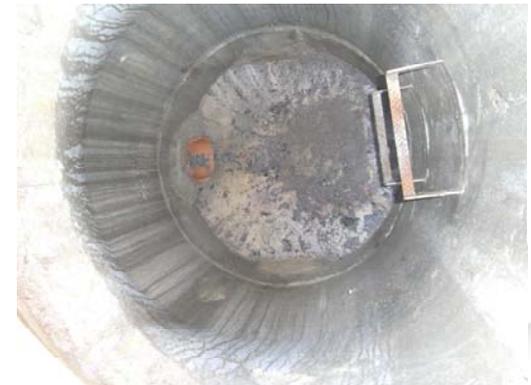
- Manholes
 - Grout Leaks
 - Minor Adjustments
 - 28 Total Manholes
 - Total Cost \$ 21,000

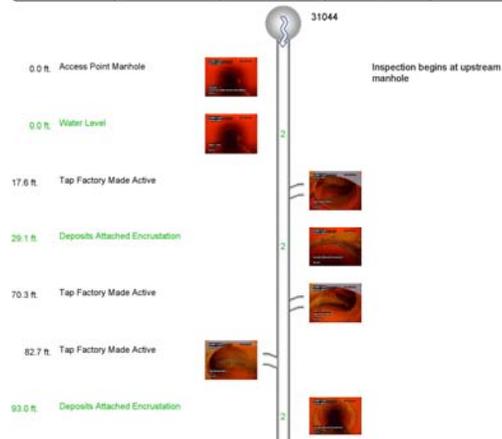
Pipe Segment Info:	City	Street	Material	Location Co-Ordinate	Sewer Use
31044 to 31043	Norwalk	Woodmyra Cr	Verified Clay Pipe	Assessment R:	Sanitary
Upstream MH 31044		Year Last Circular		Location Details	
CG Number 31043	Total Length 402.7	Year Renewed	Height 8	Width 8	Pipe Joint

- Pipes
 - Four (4) structural defects which need repair
 - Seven (7) pipes with remaining root problems
 - Over ½ of pipes with root problems
 - 20,500 feet of pipe lining recommended
 - 99 Services recommended for lining
 - Total Cost \$ 884,940
