Norwalk Aquatic Center Evaluation Report
Norwalk, Iowa

Michael Fisher, a Professional Engineer from Water's Edge Aquatic Design visited the Norwalk pool facility on March 10, 2016 to review the pool, bathhouse, and pool mechanical components and to speak with operating staff. This report summarizes the findings and offers opinions on improvements for the facility.

Norwalk, Iowa – Pool Evaluation Report
March 24, 2016

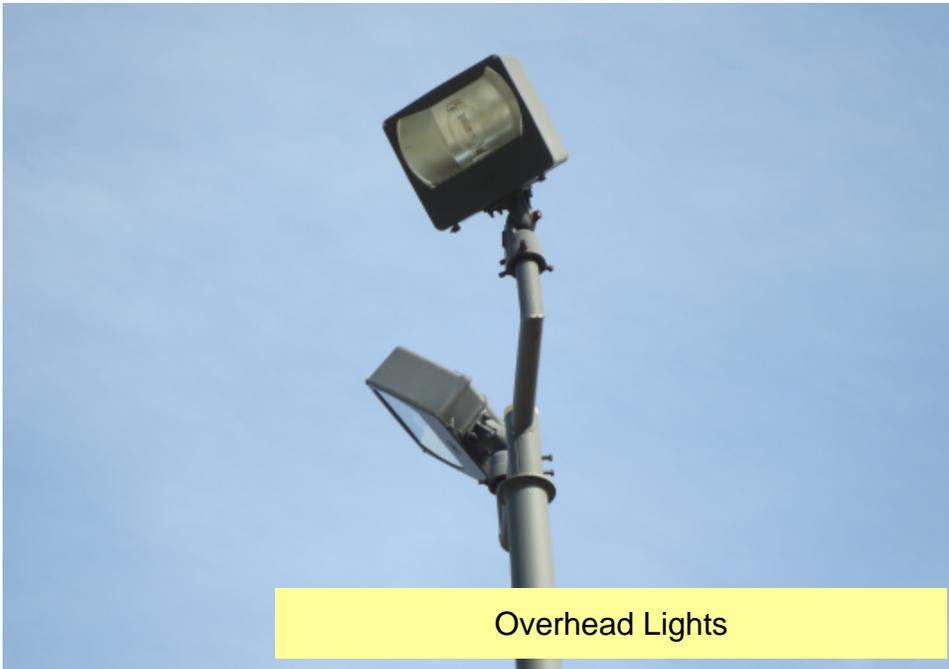
Overhead Lights

- \$3K** • Lighting for use of the facility after dark appears to be inadequate based on the apparent size and quantity of overhead light fixtures. Verification of the light levels on the deck and at the water surface should be verified with a light meter. Electricians often have light meters and could take readings. Recorded readings should be compared to the Iowa Department of Public Health (IDPH) requirements. Swimming after dark should be restricted until light levels are confirmed to be adequate. Light fixtures have been removed at the front entrance of the bathhouse.

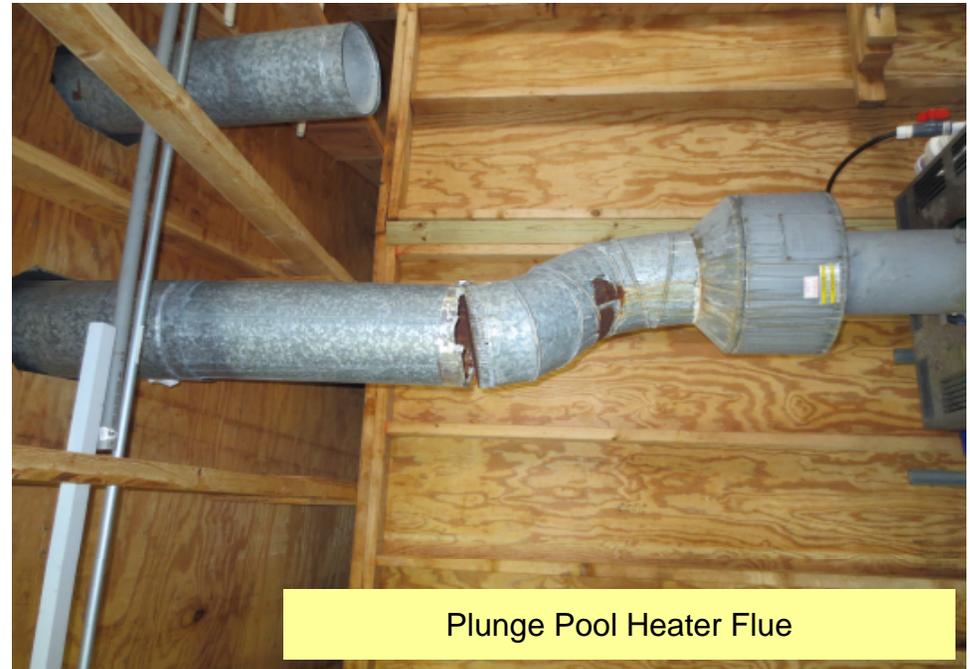
Plunge Pool Heater Flue

- The existing plunge pool heater flue has come apart and should be fixed prior to operation.
- \$1K**

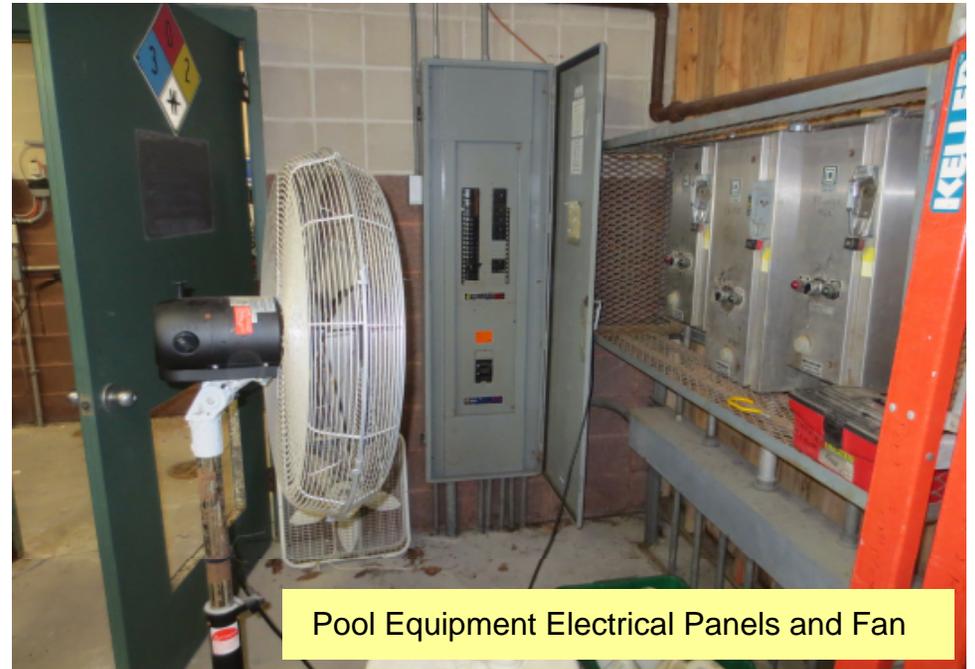
Pool Equipment Electrical Panels and Fan

- \$1K** • A fan has been set up to circulate air across the motor starter panels in order to keep the electrical systems operating. An electrician should check to see if the thermal overload protection settings of the panels can be adjusted to allow operation at a higher temperature. If not, the fan will still be needed to cool the panels for the coming swim season.

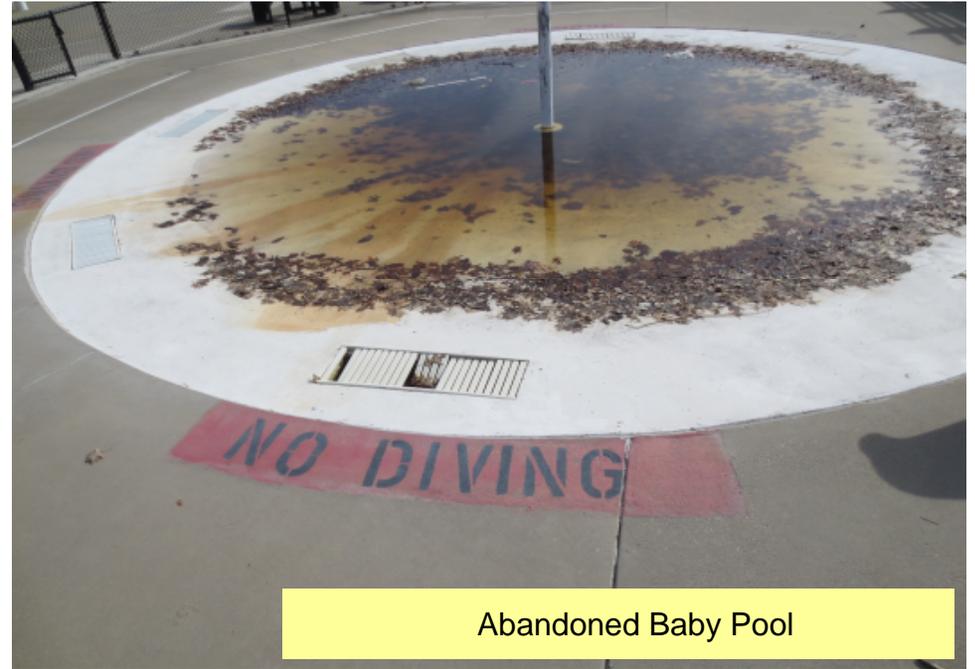
Abandoned Baby Pool

- \$0K** • The baby pool has been closed to the public and has significant offsets at the surface of the pool/deck that are trip hazards. Obviously, vertical movement of the slabs at these joint has occurred, likely due to settlement of the subgrade. Gutter grating has been broken and is hazardous. The pool has two spray features that physically appear to be safe for operation. It is recommended to continue to deny patrons access to this baby pool for the 2016 swim season.

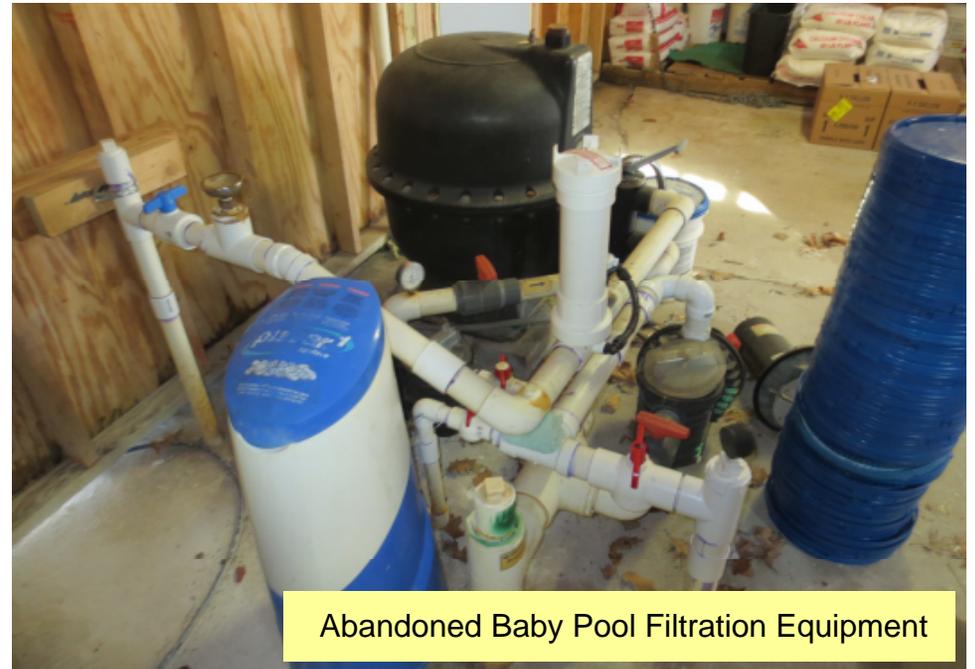
Abandoned Baby Pool Filtration Equipment

- The baby pool system has not been in operation for a number years primarily due to offsets within the pool and deck slabs. Restricting the access to the baby pool by the public continues to be a reasonable option and therefore no changes to baby pool system.

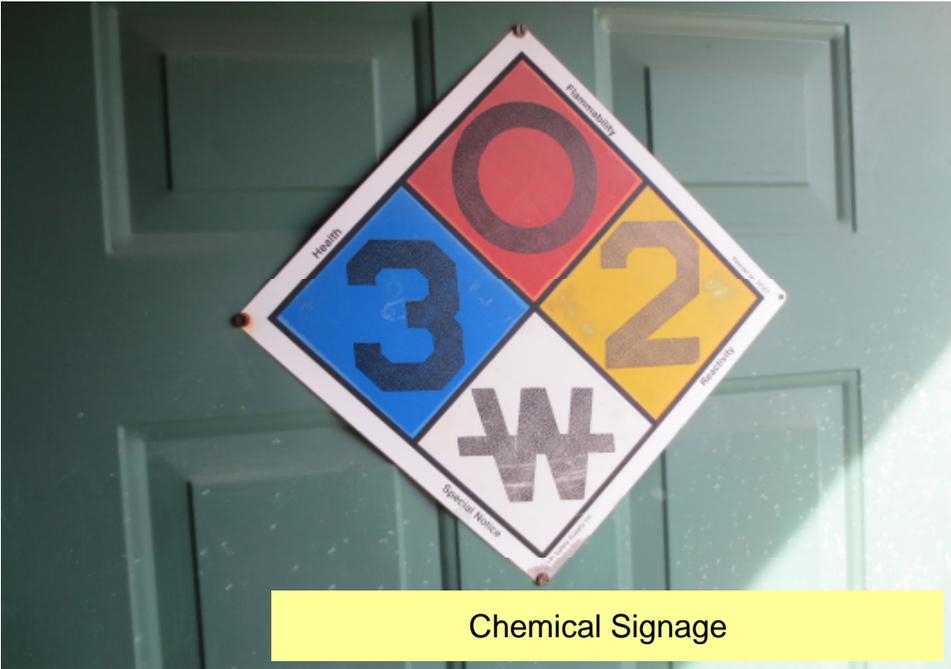
Chemical Signage

- \$1K** • Chemical warning signage on the exterior of the filter building are inadequate and should be addressed prior to chemical delivery.
- \$1K** • A light on the motor starter panel for the slide pump is missing, leaving a hole in the face of the panel. A new light should be installed or the hole plugged prior to operation.

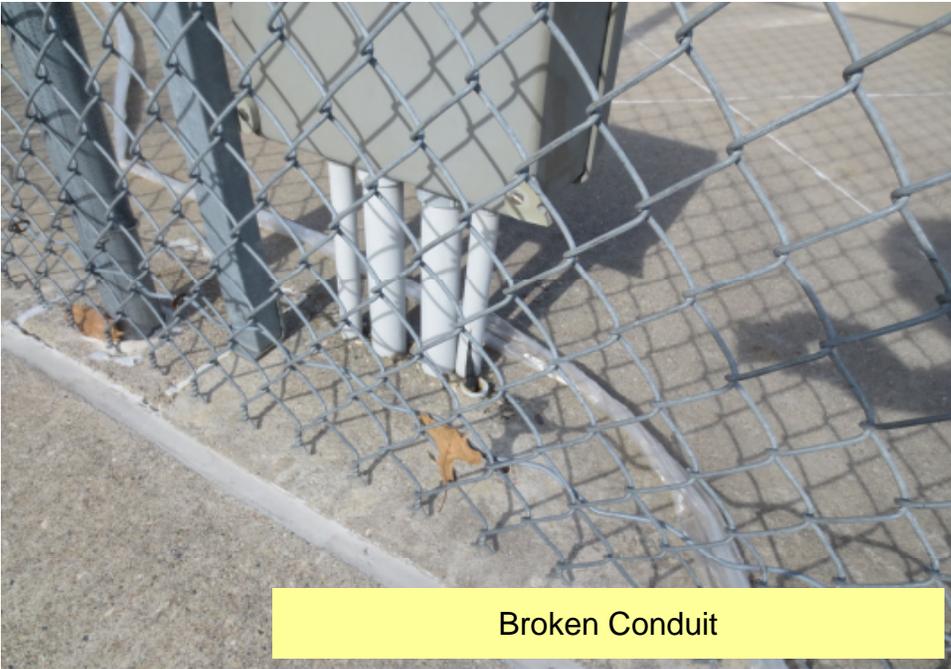
Broken Conduit

- \$1K** • One of the PVC conduits to an electrical box above the deck along the perimeter fence is broken, exposing the wiring within. This conduit should be repaired before allowing patrons near it.

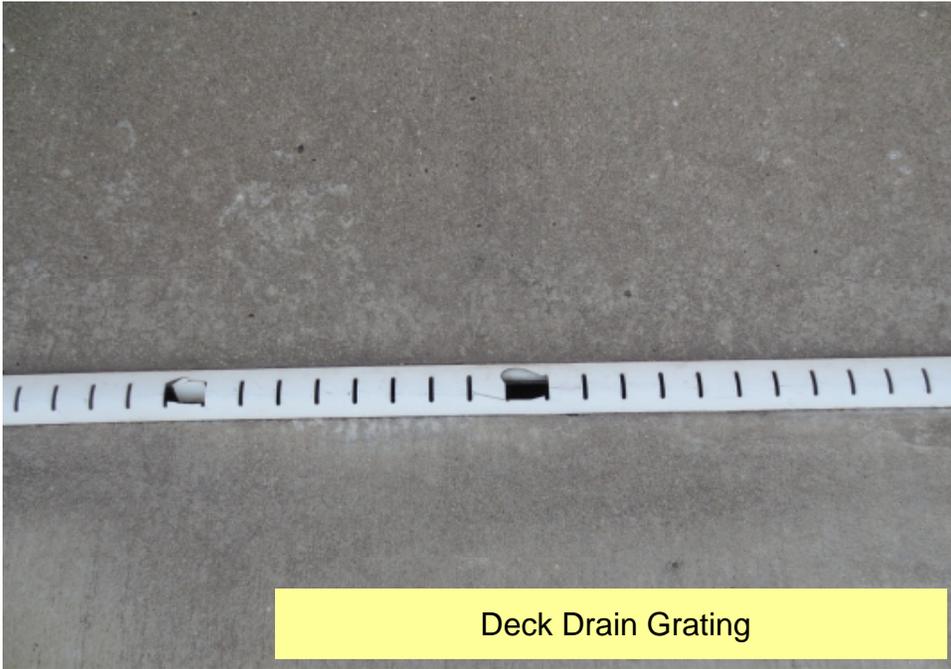
Deck Drain Grating

- \$2K** • Some trench drain grates in the deck are broken and should be repaired prior to the 2016 swim season.
- \$5K** • The trench drains do not drain quickly enough and should have the trench drain discharge piping cleaned out to prevent ponding on the deck.

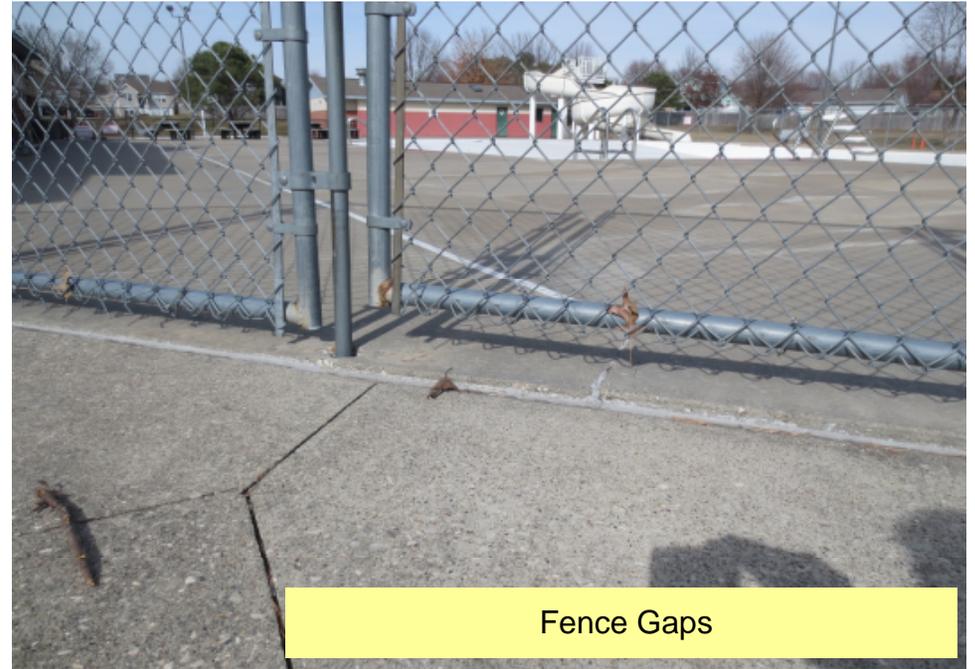
Fence Gaps

- \$3K** • Much of the chainlink fence within and around the perimeter of the facility has open selvage at the bottom and there's a notable gap between from the fence fabric to the deck surface. This could allow punctures to feet that get under the fence fabric. The fence fabric should be lowered to reduce and/or eliminate the gap prior to allowing patrons in the facility.
- \$8K** • The metallic edge on some of the waterslide step treads has corroded to the point that it has sharp edges. Removal of the corroded metals, rounding off any sharp

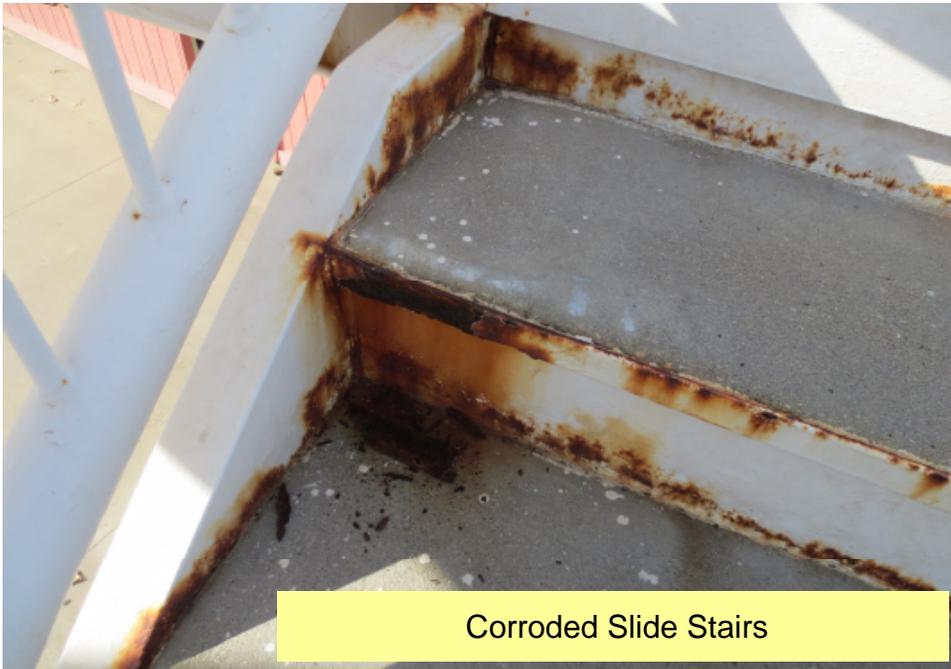
Corroded Slide Stairs

edges, and applying a protective coating should be performed prior to allowing patrons to use the slide.

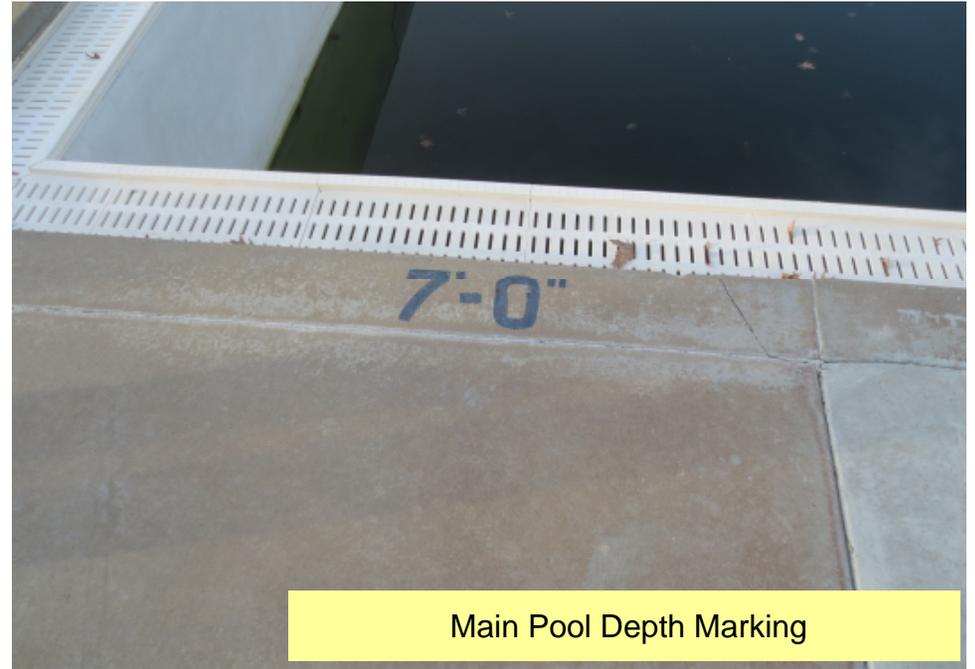
Main Pool Depth Marking

- \$2K** • Additional painted-on depth/warning markings should be added around the perimeter of the pool in order to meet requirement of the IDPH. Depth markings shall be spaced at no more than 20 feet, "no diving" markings shall be at no more than 25 feet, and "max. depth" marking should be added.

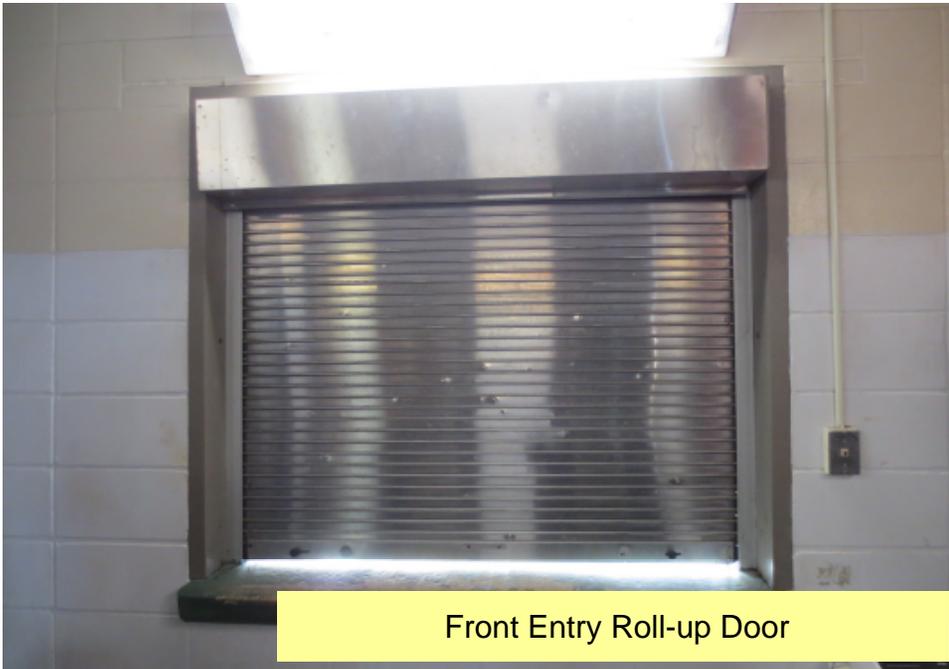
Front Entry Roll-up Door

- \$1K** • The roll-up door at the entrance window of the bathhouse has been problematic to staff when it is raised too high. Custom stop hardware could be installed to limit the height that the door can raise.

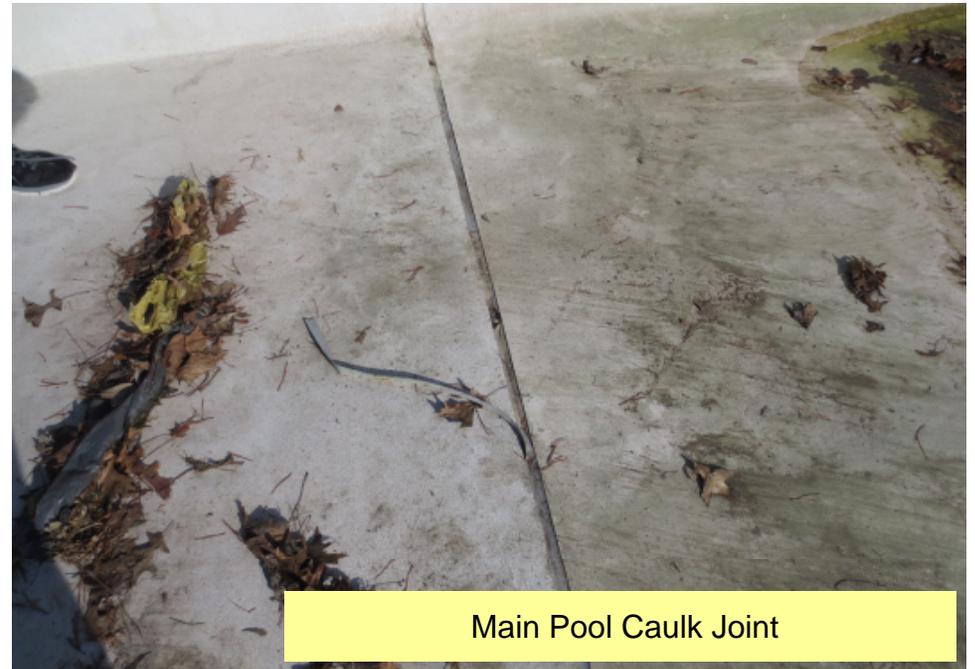
Main Pool Caulk Joint

- \$1K** • One of the pool caulk joints has been compromised and should be re-caulked to reduce the potential for pool leakage during the upcoming season.

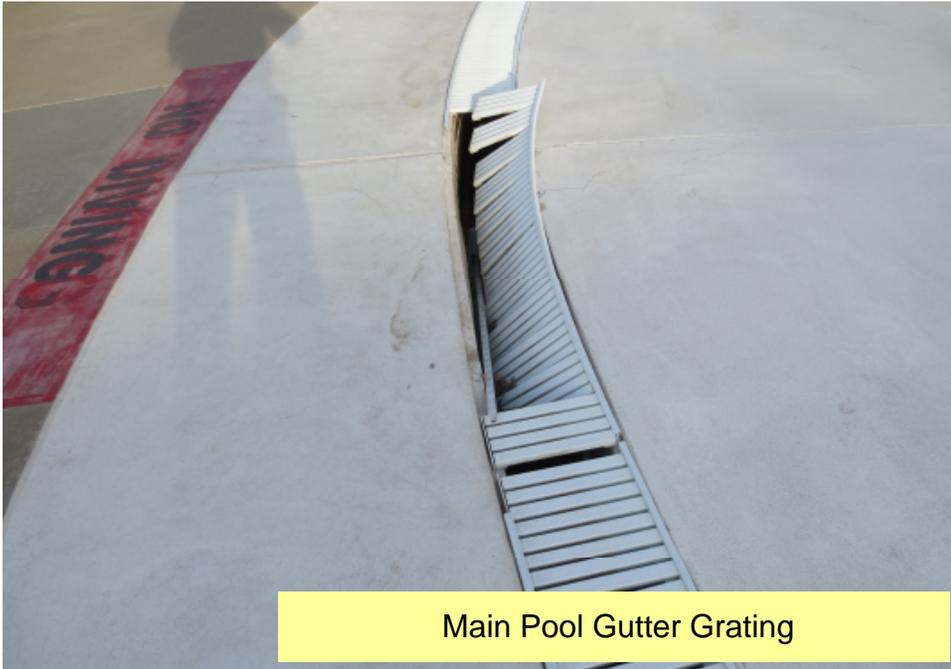
Main Pool Gutter Grating

- \$2K** • The structural integrity of the pool gutter grating has been compromised in some areas and needs to be replaced prior to the next swim season.

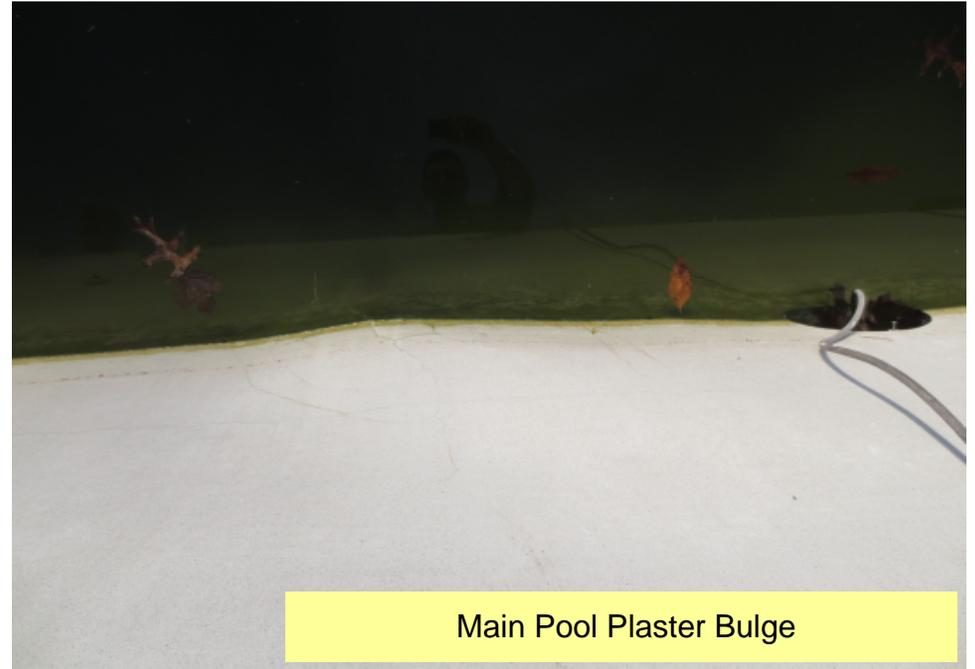
Main Pool Plaster Bulge

The main pool basin and plunge pool basin are both in good shape overall. There are some relatively minor repairs that need to be made such as repairs to a few areas of delaminated plaster surface and tile replacement. Simple bolt-on type features could certainly help the pool to be more attractive with more modern trends. The waterslide appears to be in good shape, with some attention to the metal support structure.

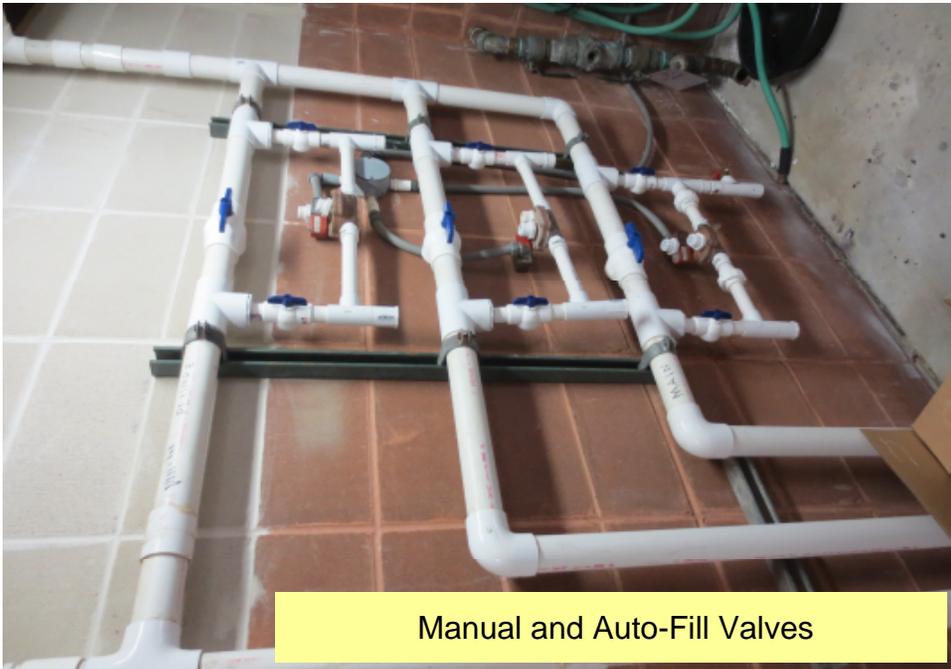
Manual and Auto-Fill Valves

- Potable water is added to the pools by operating existing valves located in the chemical room. One of these manual PVC valves and one of the automatic water feed systems is not functioning properly and should be replaced prior to the start of the next season.
- \$1K**

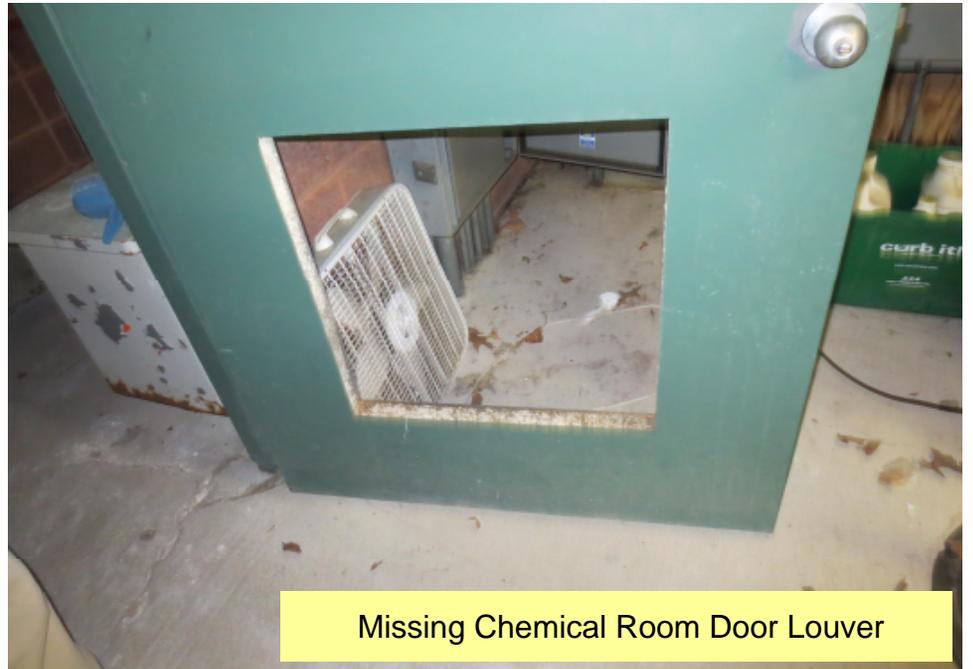
Missing Chemical Room Door Louver

- \$15K** • Ventilation of the Filter Building is inadequate for combustion air for the pool heaters. And forced ventilation should be installed in the chemical room to remove the more concentrated chemical laden air. Ventilation should be addressed prior to operation of the pool heaters and delivery of chemicals.
